Tarset Archive Group.

TARSET CASTLE -- HERITAGE at RISK

This version of the Report (V 2.0) was issued in January 2014, incorporating some revision and expansion of a few sections of text.

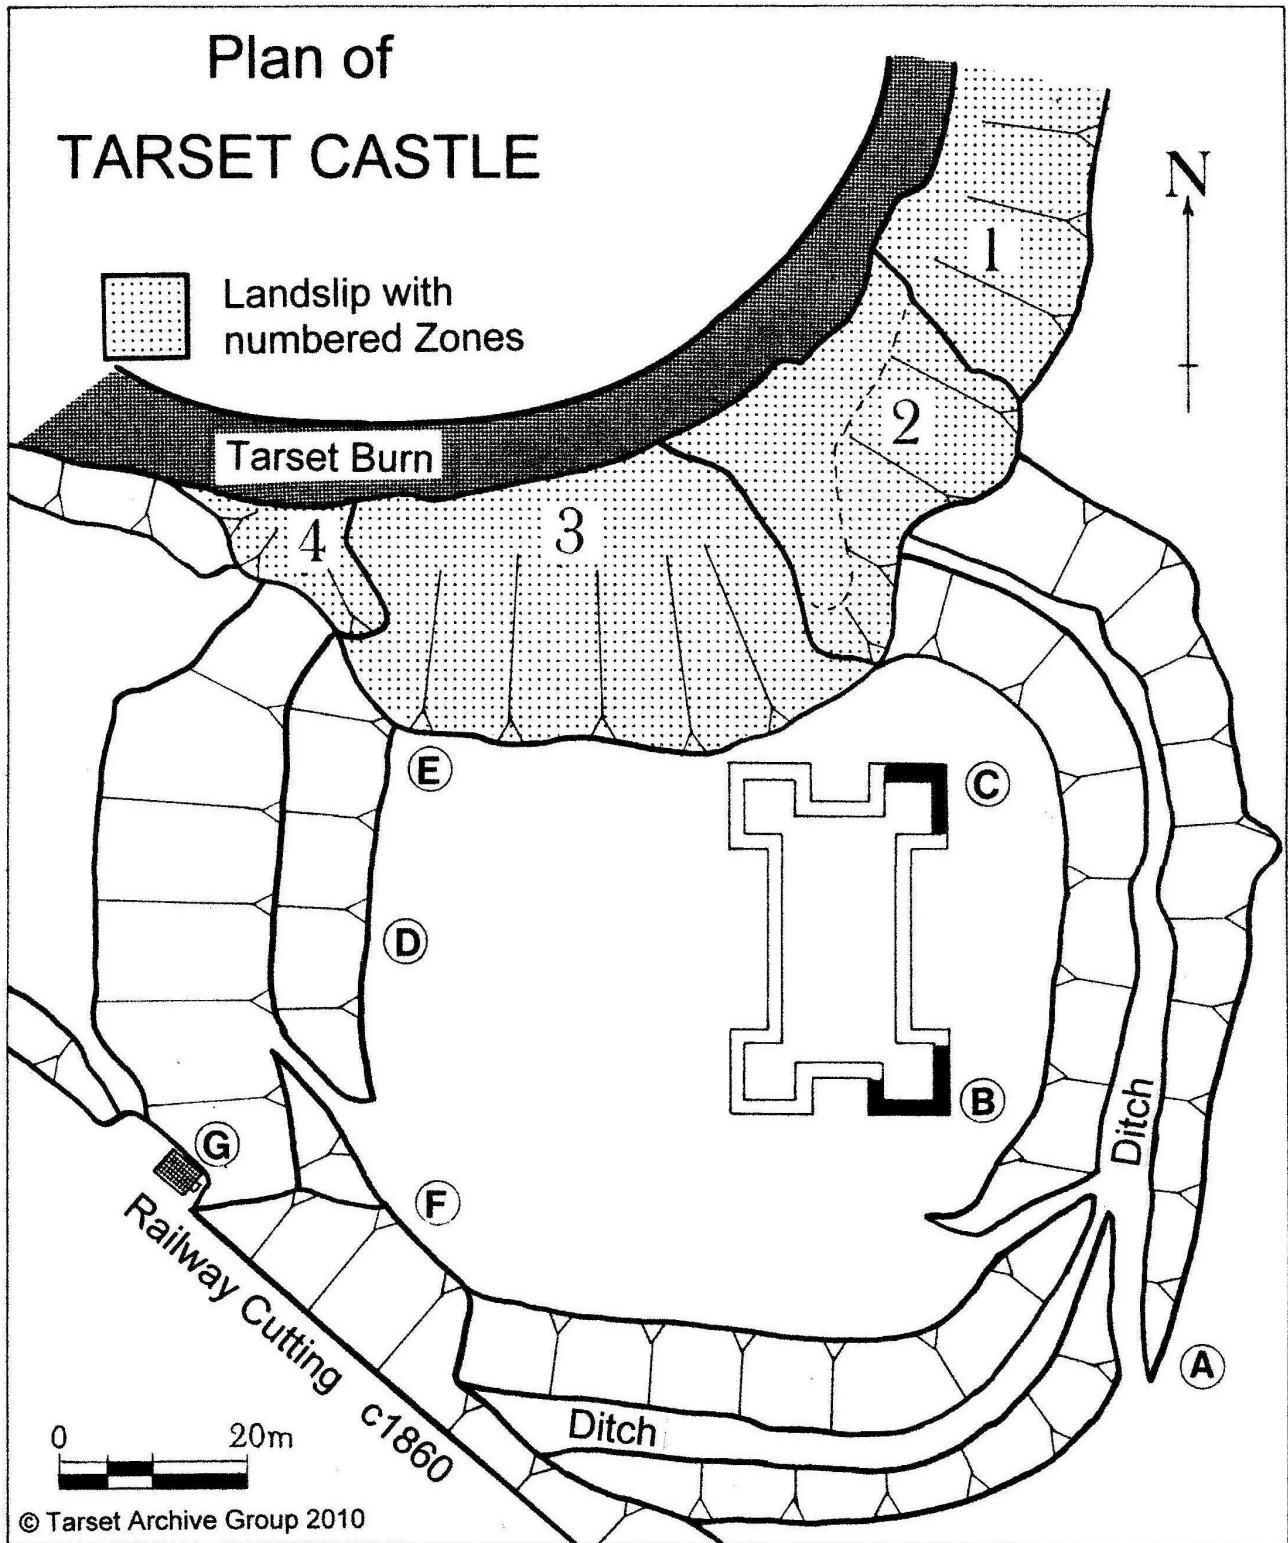
3. THE MAIN FEATURES OF THE SITE (See plan).

- A The Castle Ditch (not a moat)
- B The South East Tower: Only part of the rubble core remains.
- C The North East Tower: The remaining masonry, a chamfered plinth, is of high quality. There may be remains buried at a lower level.
- D Strategic views: North up the Tasset Valley, North-west and East to the Park, West, towards the Border 13 miles away, South, towards Dally Castle 1 mile away.
- E The North Slope. A steep natural slope, the toe of which is under attack from the Tasset Burn. Landslipping now threatens the castle remains. (See below)
- F. Excavating the cutting for the Border Counties Railway in about 1860 removed part of the castle mound and ditch.

G Railway Lengthmen's Hut: Used as a bothy and to store tools by men who patrolled the line daily, carrying out maintenance. Now derelict.
