# Tarset Castle Northumberland

archaeological post-excavation assessment and earthwork survey

report 3999 December 2015

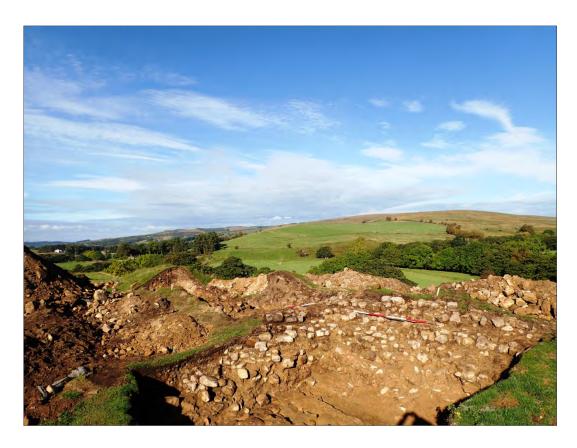
Figure 7: General shot across the excavation, looking north-west

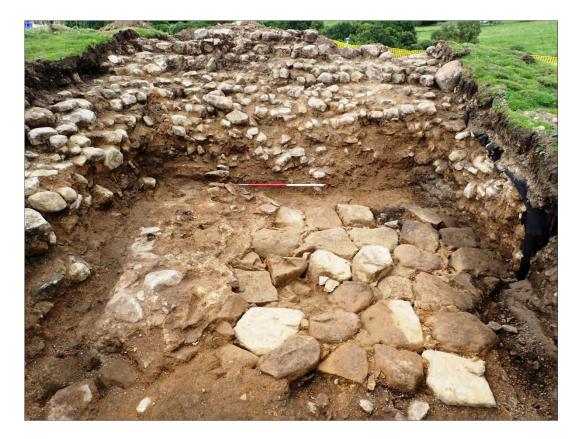
Figure 8: Structural foundation [F14], looking north

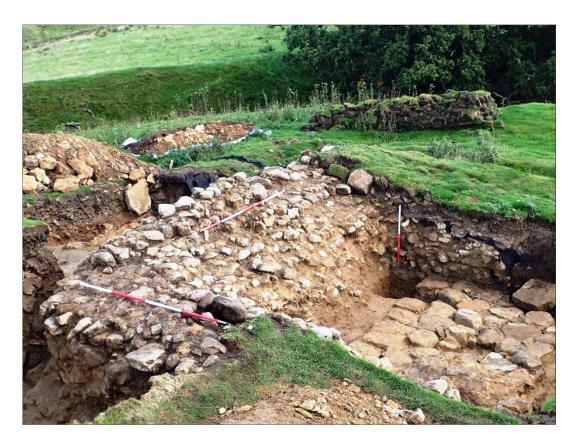
Figure 9: Overview of north-east tower wall [F13], looking north-east

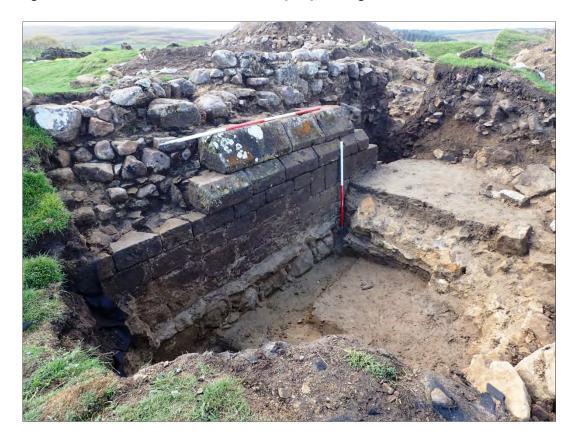
Figure 10: North face of north-east tower wall [F13], showing foundation [F93], chamfered stonework, and concrete [97=28], looking south-west

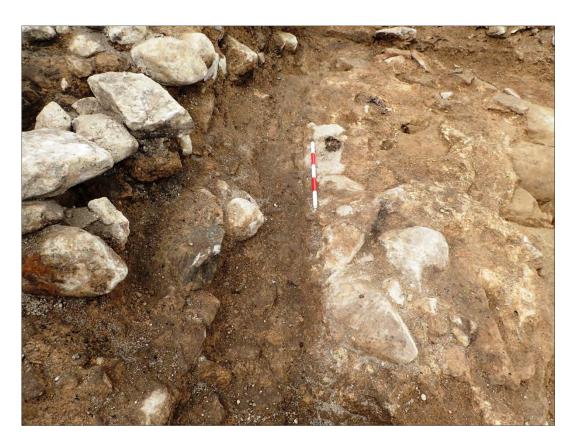
Figure 11: Impression [F68] left by facing stones, looking north

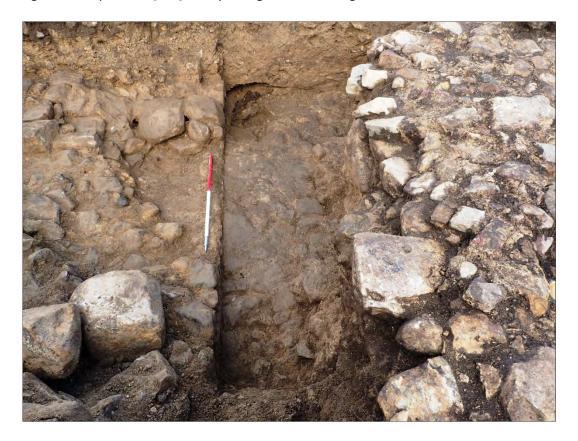
Figure 12: Trench for facing stone [F103] upon structural foundation [F105], wall [F13] (right) and wall [F57] (rear left), looking north

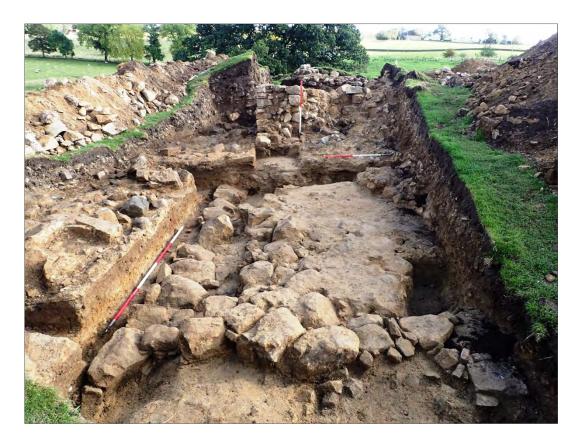
Figure 13: Structural foundation [F79] for north-west tower, looking east

- 5.9 Deposit [82/88] in trench A2 was cut by the truncated remains of a large foundation trench [F81: 2.3m+ north/south, 5.4m+ east/west, 0.4m deep] for a sandstone foundation [F79=F78: 4.8m+ east/west, 3m+ north/south, 0.4m thick] (Figure 13). This truncated structural foundation was constructed from large sub-rounded and sub-angular sandstone (<400x500x400mm), and extended toward the southern edge of the trench below later deposits and features (Figure 4: sections 1 and 5). A layer of concrete and mortar [F56: 3.9m east/west, 2.6m+ north/south, 0.1m thick] had been applied to the upper surface of foundation [F79] and was overlain to the east by the remains of a wall [F75: 2.6m+ long, 1.4m wide, 0.2m thick] (Figure 14). The remains comprised the fragmentary mortared rubble core of the wall only, constructed from sub-rounded sandstones (<200x360x150mm).

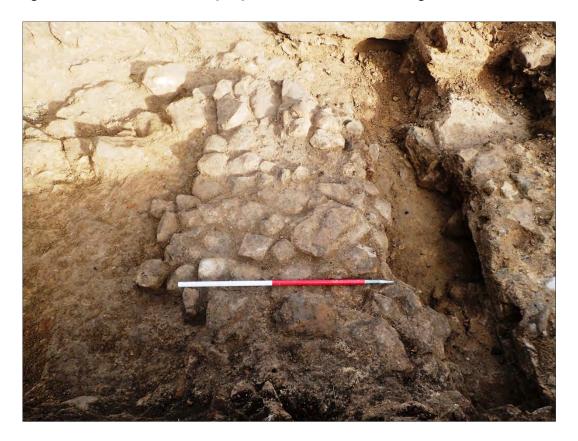
Figure 14: The remains of north-west tower wall [F75], looking north

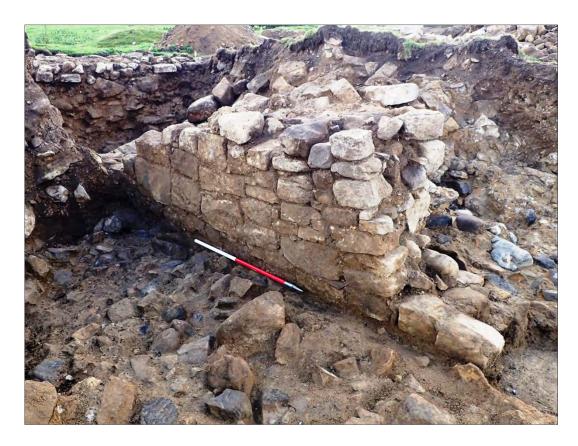
Figure 15: North face of curtain wall [F57], looking south east

- 5.10 A concreate and mortar raft was poured between walls F75 (A2) and F13 (A1) [F76=F104: 6.5m east/west, 3.2m+ north/south, 0.1m thick]. This concrete raft provided a stable foundation for the construction of east/west wall [F57: 6m long, 0.8m wide, 1.2m high] (Figure 15). The clay-bonded wall was constructed from random coursed squared sandstones (<500x300x400mm; Figure 4: section 6). To the south of the wall an extensive layer of concrete and stone [F59: 6.4m east/west, 2.6m+ north/south, 1.3m thick] had been laid (Figure 16). A small intrusive slot [F98: 0.7m in diameter, 0.3m deep] was identified cutting the north-western corner of the base of trench [F103] and concrete raft [F76], creating a partial void in the lower

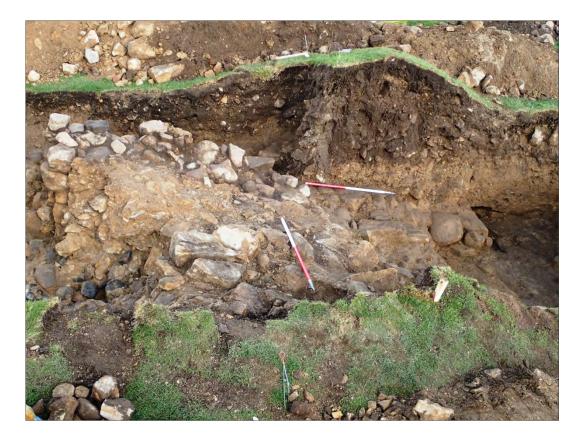
Figure 16: Concrete [F59] with wall [F57] to rear, looking north

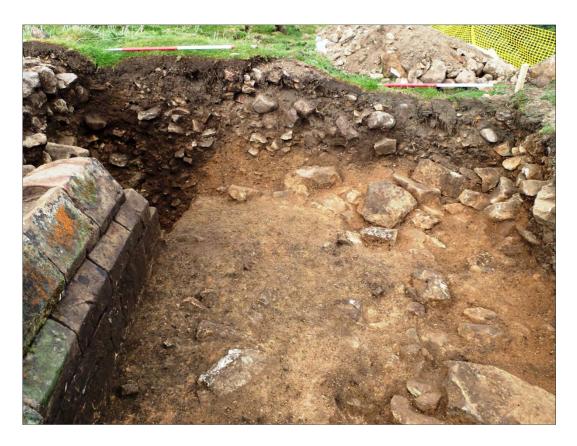
Figure 17: 19th century excavation trench [F63] (rear left) cut over robber trench into foundation trench [F101], with concrete [28=97], looking west

5.14 Truncating the extensive rubble deposits [64] and [65] to the west, and rubble deposit [34] to the east, was a large trench [F63=F66: 6m+ east/west, 2m north/south, 0.9m deep] excavated over the northern faces of walls [F13] and [F57] and reaching the foundations of the former wall (Figure 17). The trench was filled by deposit [62=53] comprising brown sandy-silt containing frequent sub-rounded and sub-angular sandstones. A small body sherd of post-medieval unweathered green bottle glass was recovered from this deposit. This trench, and a deposit of dark brown sandy silt [7] (previously identified within trench 3 during the archaeological

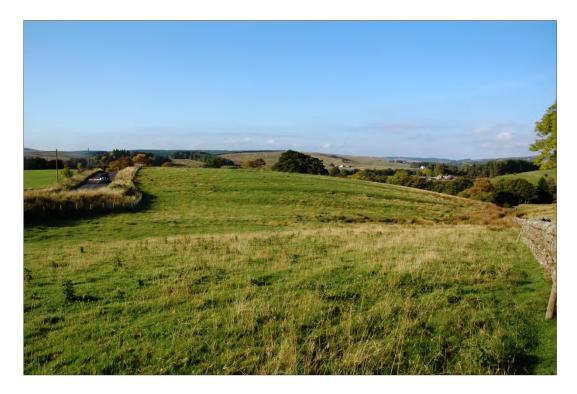
Figure 18: Overview of the eastern field, with terracing banks [EF1; EF2; EF3], looking west

Three low north/south orientated banks [EF1; EF2; EF3] were recorded in the field to the east, forming three terraces on the eastern slope of the low hill to the east of the castle mound (Figures 18 and 19). The latter of the banks [EF3] was barely visible to the north, and became more pronounced to the north. The remains of ridge and furrow earthworks [EF4], orientated north/south, were identified on each of the lower two terraces, and on the apex of the rise, curving slightly to the north and becoming less visible to the west (Figure 20). On the western slope of the low hill a very slight low bank [EF5] was recorded, extending from the south and petering out as it curved to the north. A further adjacent bank was identified curving north/south

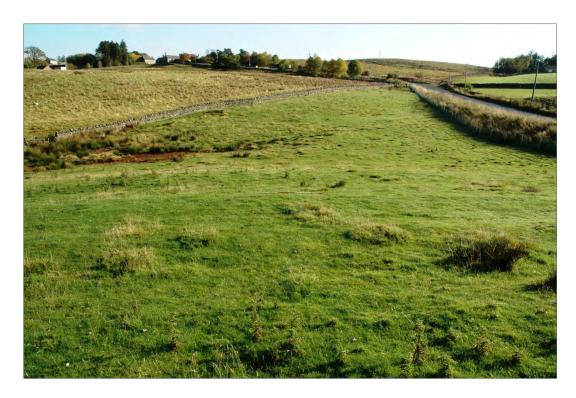
Figure 19: Terracing banks [EF1; EF2; EF3], looking east

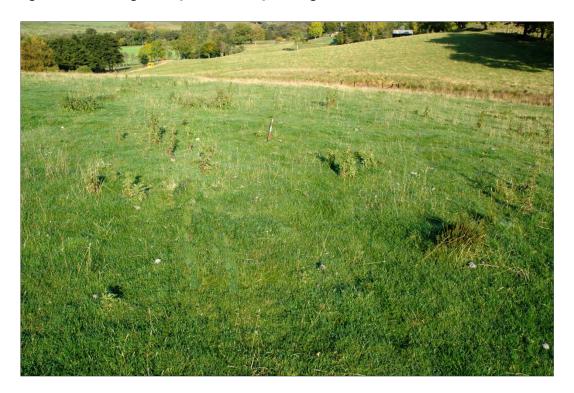
Figure 20: Ridge and furrow earthworks [EF4], looking north

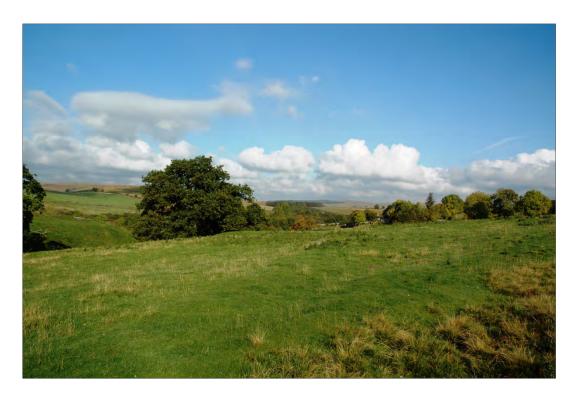
Figure 21: Low banks [EF6] and [EF7], with road construction ditch and banks [EF8] visible in the foreground, looking north

around the base of the western slope of the low hill, with a break at the mid-point corresponding to the location of the bridge abutment [EF18] on the south-eastern upper edge of the castle ditch (see below). The southern part of the bank was designated as [EF7], and the northern as [EF6] (Figure 21).

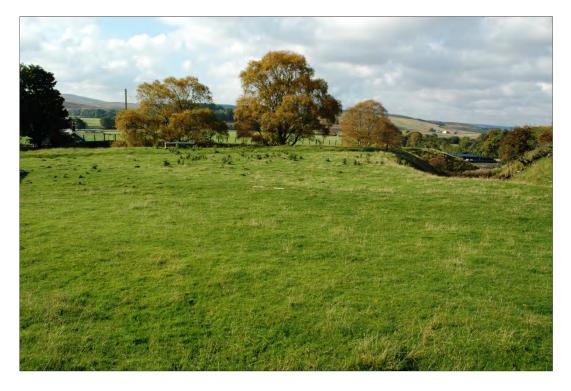
Figure 22: Low bank [EF9], leading away from access track [EF17], looking west

6.6 To the south, a series of irregular banks and a shallow drainage ditch [EF8] extended parallel to the north-east/south-west road, probably related to minor changes in the course of the road over the last century. In the area immediately to the west of the castle mound, a further low bank [EF9] was recorded, leading away to the southwest from the current access route [EF17] onto the castle via the castle ditch (Figure 22).

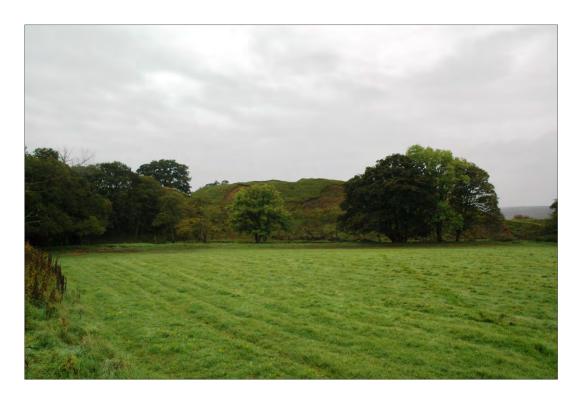
Figure 23: Castle mound [EF16], showing northern land slip scars, looking south

#### Castle mound and ditch (Figures 5a, 5b and 5c; 23)

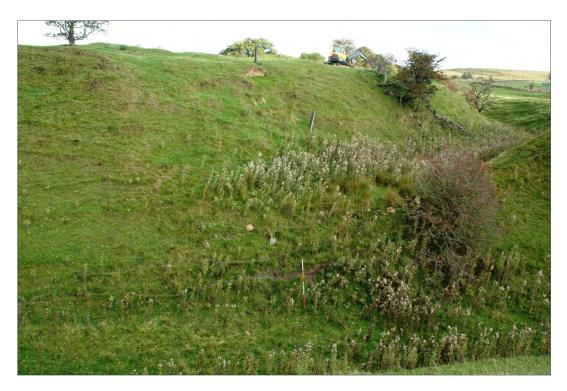
Figure 24: Southern area of the castle ditch [EF15], with the truncation by the railway cutting [EF14] visible in the foreground, looking north-east

- 6.7 The castle ditch [EF15] extends eastward from the western truncation by the railway cutting, turning north-east just prior to the current access route [EF17] onto the castle (Figure 24). Beyond the access route, the ditch continues to extend to the north-east, turning again to the north-west and terminating at the point of truncation by the land slip to the north (Figure 25). A hollow [EF18] was recorded, located on the exterior upper south-eastern edge of the ditch, in the area of the possible bridge abutment (previously identified during the archaeological evaluation (Archaeological Services 2015; Figure 26). Eroded soil from this hollow has partially infilled parts of the ditch in this area. Further areas of erosion and damage by tree roots were recorded just to the north in this area. In addition, numerous sheeptracks were recorded within the ditch, particularly on the southern edge to the south (Figure 27). A further track or footpath was identified leading down the southern edge of the ditch at the point of intersection with the railway cutting.

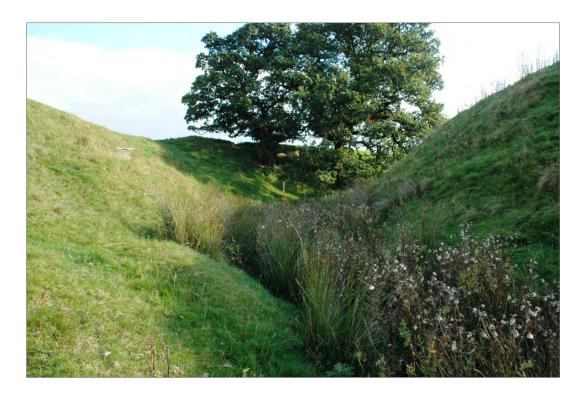
Figure 25: The north-eastern area of the castle ditch [EF15] at the point of truncation by the land slip, looking south

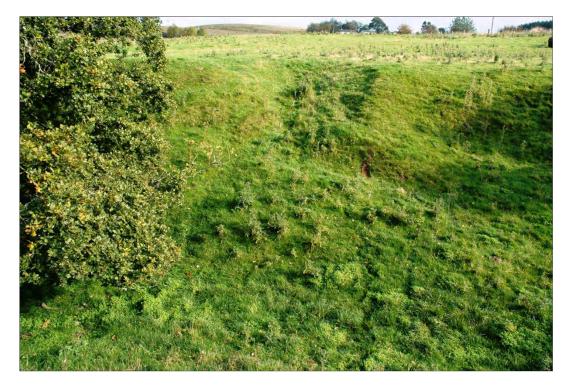
Figure 26: Bridge abutment [EF18] on the eastern edge of castle ditch [EF15], looking east

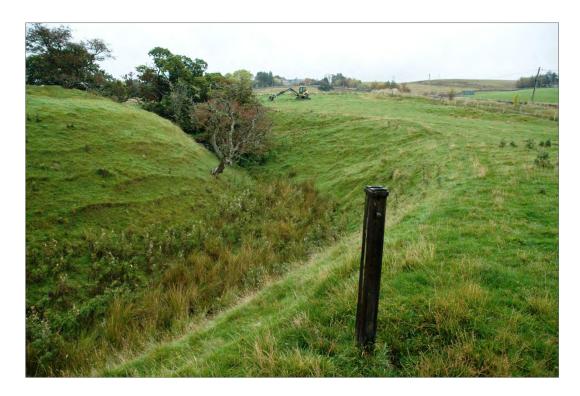
Figure 27: The south-eastern area of the castle ditch [EF15] showing sheep tracks, looking east

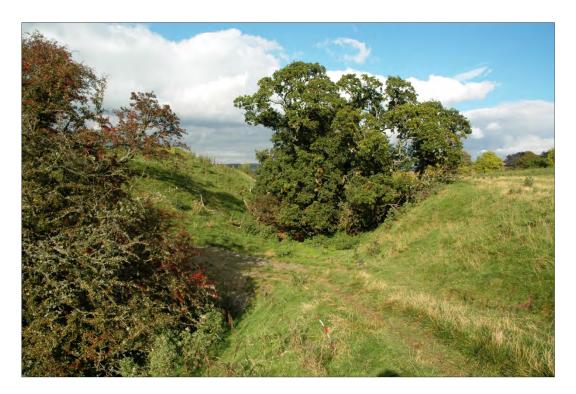
Figure 28: Access track [EF17] leading into the south-east corner of castle ditch [EF15], looking north

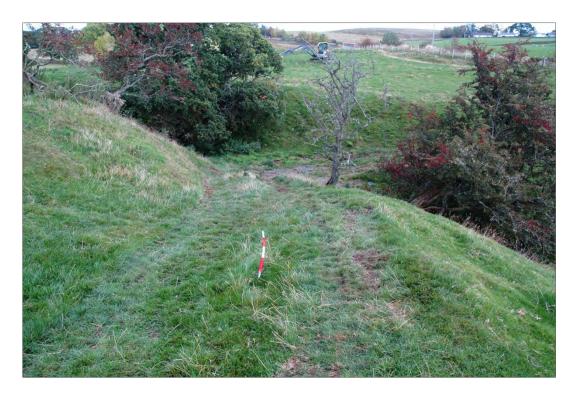
Figure 29: Access track [EF17] leading into the south-east corner of castle ditch [EF15], looking east

- 6.8 The modern access route [EF17] leads into the castle ditch [EF15] at the south-east corner, turning westward at the base of the ditch to lead up onto the castle mound [EF16] (Figures 29 and 30). Whilst the access track was modified and stabilised during recent geotechnical works, it is likely that the track is at least post-medieval in date (see below). The south-western corner of the square castle mound [EF16] was truncated in 1860 by the cutting for the Border Counties Railway line, whilst the land slip in the later 19th century, and continued related erosion, has truncated a large area of the northern mound (Figure 31). To the west the mound slopes sharply, with slumped and eroded soil creating a more gentle gradient around the base of the escarpment (Figure 32). Two tracks were identified leading northward down this western face, the southernmost of which was most substantial, with the other being little more than a sheep track (Figure 33). A further section of the south-western corner of the mound has been removed to create a cutting for the construction of the railway lineman's hut [EF13] (see below).

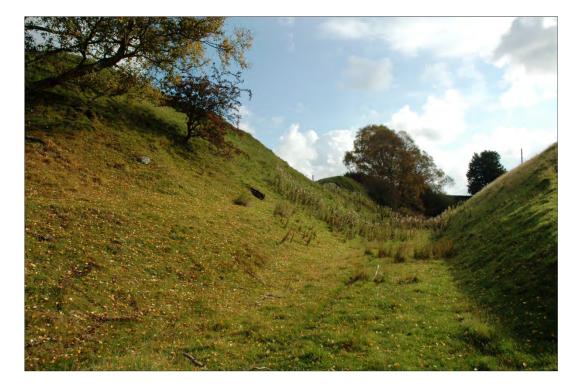
Figure 30: The castle mound [EF16] at the point of truncation by railway cutting [EF14], looking south-east

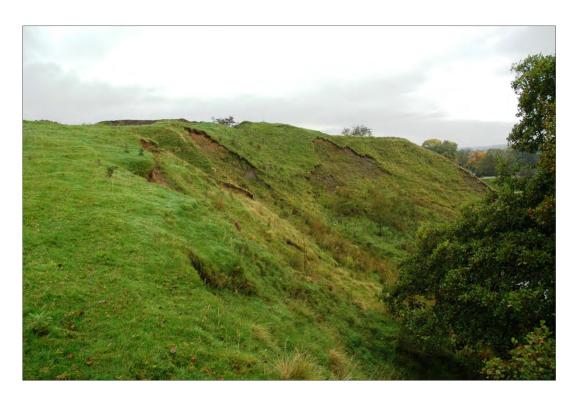
Figure 31: The area of the land slip truncating the northern area of castle mound [EF16], looking south-west

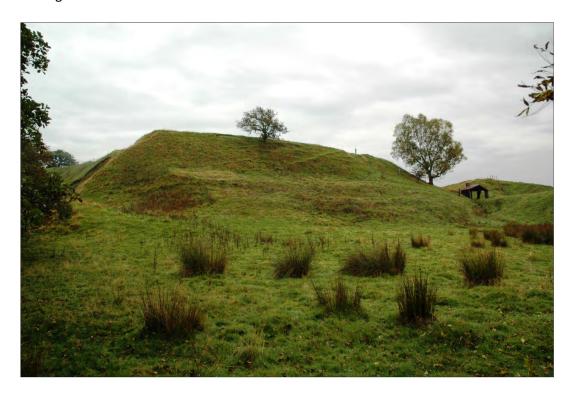
Figure 32: The western face of the castle mound [EF16], with the land slip visible (left), looking east

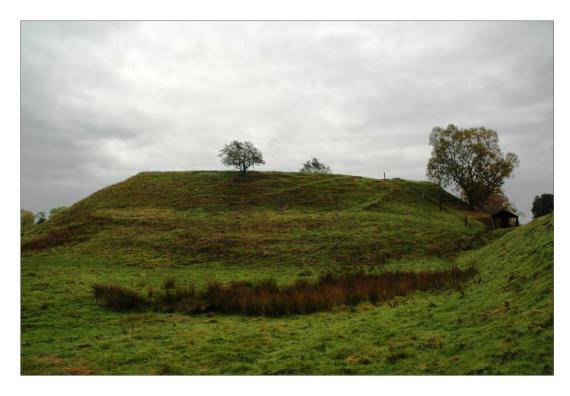
Figure 33: The western face of the castle mound [EF16], showing tracks leading down the escarpment, looking east

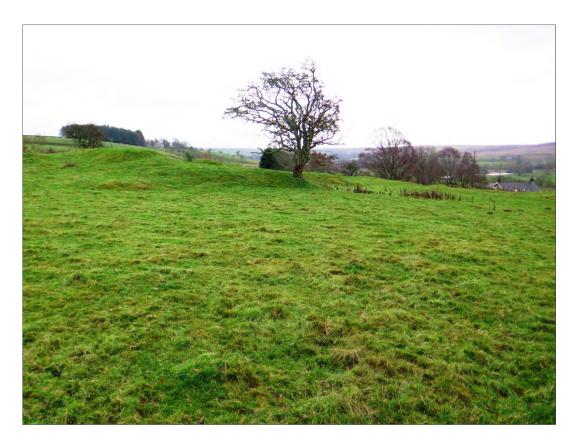
Figure 34: Spoil heaps [EF25] to the south of the structural remains of the castle, looking west

- 6.9 On the upper area of the castle mound a group of five low mounds and a shallow depression [EF25], probable spoil heaps and features relating to the demolition of the castle, were identified adjacent to the entrance to the access track [EF17] (Figure 34). Beyond these spoil heaps the track leads onto a relatively flat area occupying approximately a third of the upper western area of the castle mound (Figure 35). A low bank [EF26] was identified extending along the upper edge of the western escarpment of the mound (Figure 36).

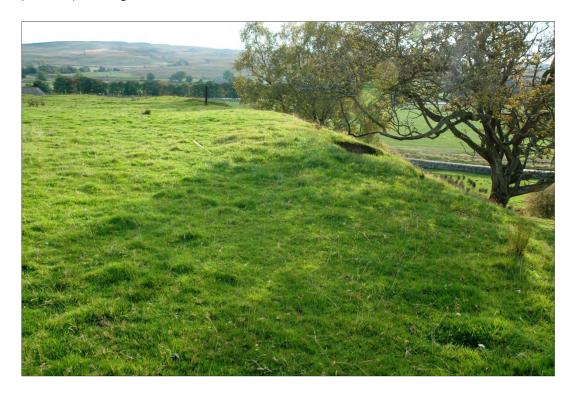
Figure 35: The western flat area of the castle mound [EF16], with spoil heaps [EF22] visible (rear left), looking south-east

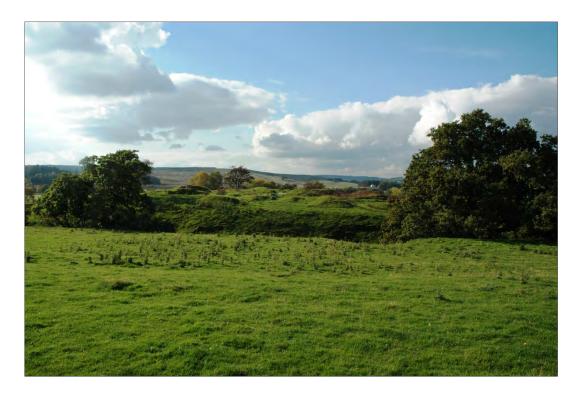
Figure 36: Slight bank [EF26] running along the upper edge of the western escarpment of the castle mound [EF16], looking south

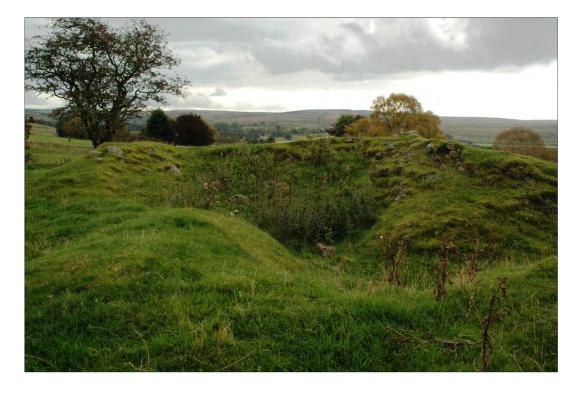
Figure 37: Overview of the structural remains of the castle on the eastern side of the castle mound [EF16], looking west

- 6.10 The remaining area of the castle mound [EF16] to west was dominated by spoil heaps relating to the demolition of the castle, and the partially exposed remains of structural elements of the castle excavated in the late 19th century (Figure 37). The most readily indefinable remains from this latter group is the exposed stonework [EF19] in the south-east corner of the mound (Figures 38-40). The rubble wall core forms an approximate U shape, with part of the wall leading off to the west, constituting the remains of the south-east tower of the castle exposed during the 19th-century archaeological excavations. A number of low banks and trenches were identified to the north, east and south of the wall [EF30] [EF31] [EF32], created as a result of these excavations. To the west a shallow trench extends around a slight mound [EF20] which forms the possible remains of the south-west tower, subject to extensive demolition with the stonework removed to the level of the foundations (Figure 41). The remains of the north-east tower [EF27; cf. F13] are much more substantial. Prior to the recent archaeological evaluation it was clear that the wall had been partially exposed during the 19th century excavations, with the northern and eastern faces forming an L shape (Figure 42). Sections of chamfered stonework were visible on these faces and much of the upper area of the wall was sealed by turf and moss only. The excavations detailed above have established that the tower has a similar U shape layout to that in the south-east corner (Figures 8 and 9). A low bank [EF33], which extended around the eastern and northern sections of the tower wall, was created as a result of the 19th century excavations. The area of the northwest tower was overlain by a large low mound [EF29] which extended into the central area of the castle, and which was partially removed during the subsequent excavation. A shallow irregular trench that extended along the western side of the castle remains [EF21], between the north-west and south-west towers, probably marks the position of the western curtain wall which has also been robbed to the level of the foundations (Figure 43).

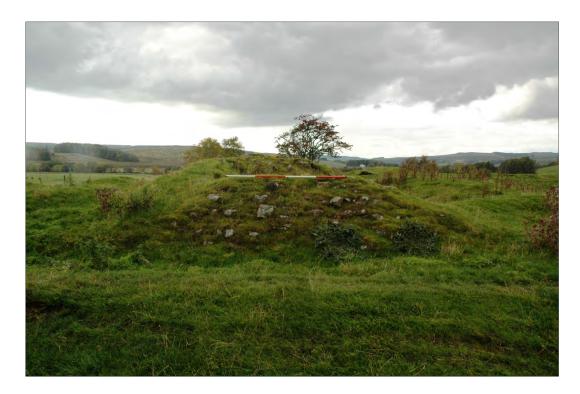
Figure 38: The remains of the south-east tower [EF19] of the castle, with related excavation spoil heaps [EF30] visible in the foreground, looking south

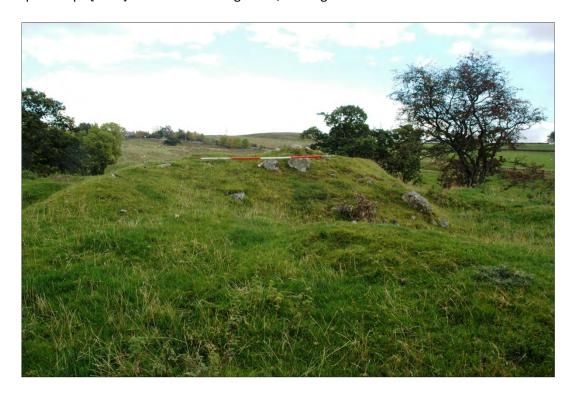
Figure 39: The remains of the south-east tower [EF19] of the castle, with related excavation spoil heaps [EF31] visible in the foreground, looking west

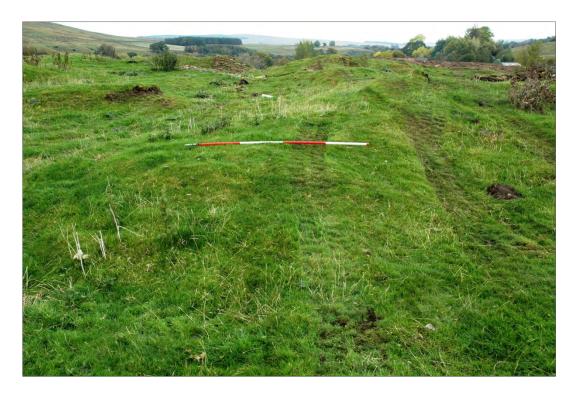
Figure 40: The remains of the south-east tower [EF19] of the castle, with related excavation spoil heaps [EF32] visible in the foreground and right, looking south

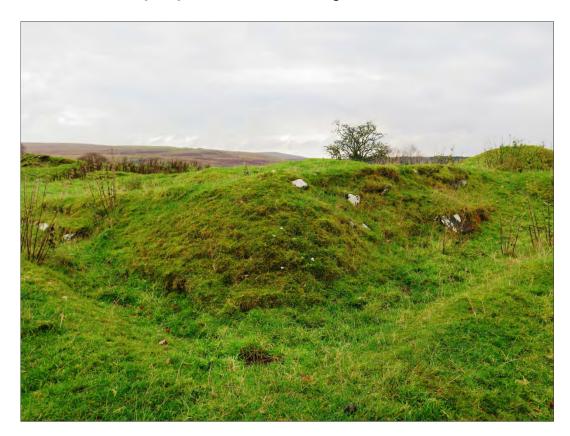
Figure 41: The robbed remains of the south-west tower [EF20], with the robber trench for the western curtain wall [EF21] visible to the rear, looking north

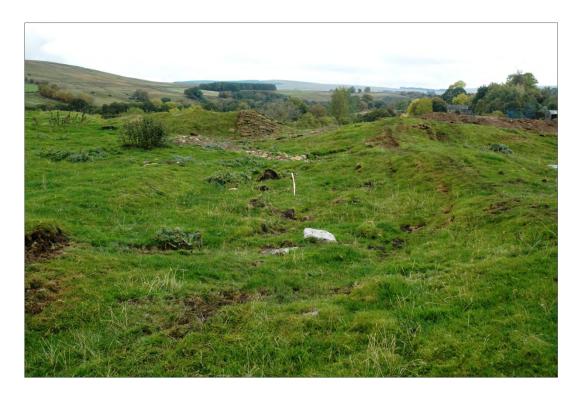
Figure 42: North-east tower [EF27] (*c.f.* [F13]) prior to excavation, with the trenches relating to the 19th century excavations visible around the base of the earthwork, looking south-west

- 5.5 The remains of the east-facing arm of the north-east castle tower [F13] wall extended north/south for 5.4m, turned east/west for 6.6m, and returned along the west face of the tower for a further 6.8m, extending beyond the southern edge of the trench (Figure 9). At its widest point the tower wall was up to 3.4m thick and stood to a height of 1.6m. Much of the wall survived as a mortared rubble core only, and was constructed from mainly sub-rounded sandstones (<400x300x400mm). Whilst most of the dressed stone had been removed from the wall, four courses of mortared facing stones were identified *in situ* at lower levels along the north face, constructed from regular coursed, dressed sandstones (<450x200x250mm). The facing stones were overlain by the partial remains of two courses of chamfered sandstones (900x300x250mm; Figure 4: section 4; Figure 10). Further sections of chamfered stonework were observed in the unexcavated east face of wall [F13] (Figure 42).

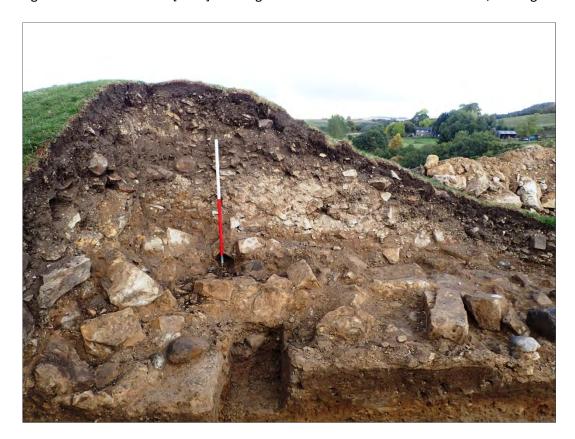
Figure 43: Robber trench [EF21] marking the western curtain wall of the castle, looking north

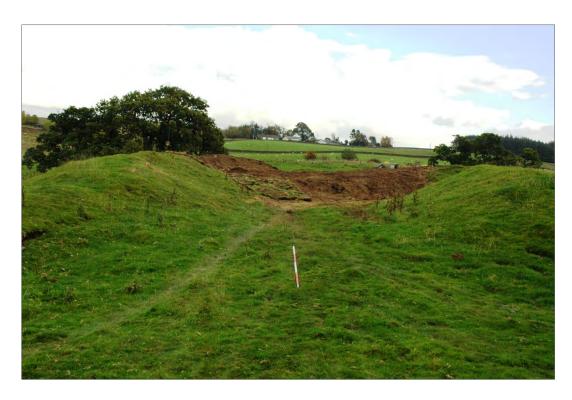
Figure 44: Spoil heap [EF21] to the north-west during excavation, showing demolition rubble overlain by spoil from the 19th century excavations, looking north

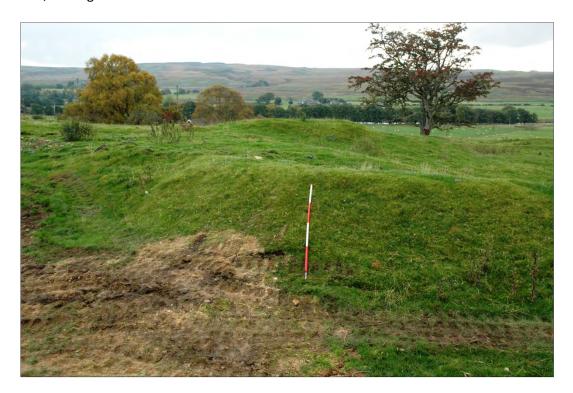
Figure 45: The gap [EF23] providing access to the castle remains during the planned demolition, with spoil heaps [EF28] to the left, [EF22] to the right and [EF29] visible to the rear, looking east

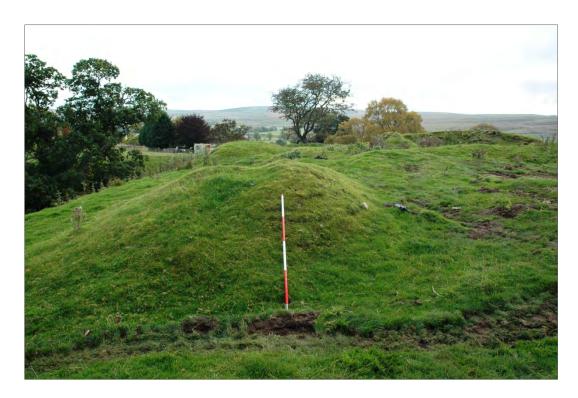
Figure 46: Group of spoil heaps [EF22] to the west of the structural remains of the castle, looking south

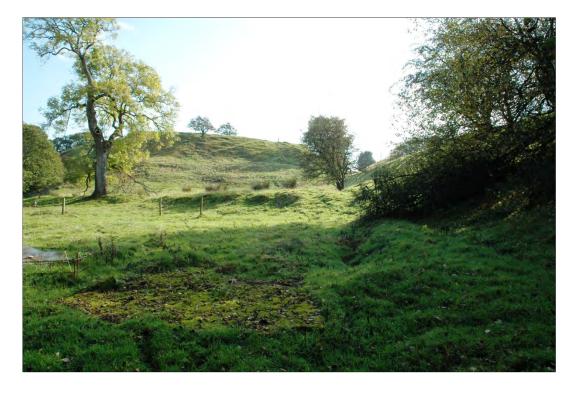
Figure 47: Group of spoil heaps [EF24] to the west of the structural remains of the castle, looking south

- 6.11 The majority of the spoil heaps associated with the demolition and stone reclamation were located along the eastern and western sides of the structural remains of the castle. A large irregular mound was identified [EF28], truncated to the north-east by the land slip and partially excavated during this phase of the archaeological works (Figure 44). The gap between this spoil heap, and the group of spoil heaps to the south [EF22] resulted in the creation of a narrow access route [EF23] into the castle area from the west (Figure 45). This latter group of spoil heaps [EF22] comprised a group of three large mounds along the west, a slight bank to the south-east, and a shallow hollow or depression to the north-west (Figure 46). To the east of the structural remains of the castle a group of five mounds [EF24], arranged north/south along the upper edge of the castle ditch, were recorded (Figure 47).

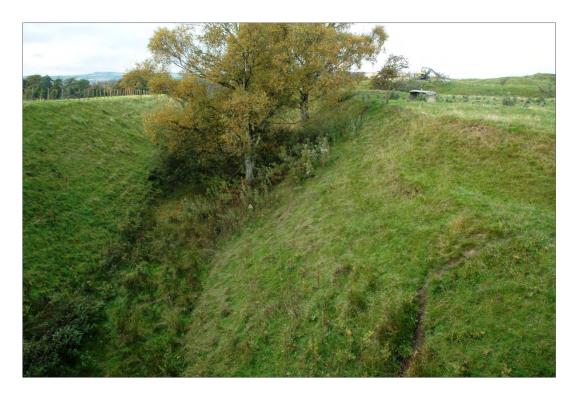
Figure 48: Terracing bank [EF12] to the west of the castle mound [EF16], with railway fencing bank and ditch [EF11] and embankment [EF10] visible (right), looking south-west

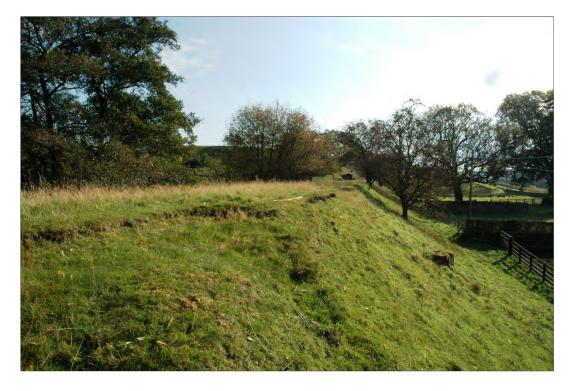
Figure 49: Railway cutting [EF14] from the southern road bridge, with castle mound [EF16] visible (right rear), looking north-west

- 6.13 From the stone bridge that crosses the road to the south of the castle the steep sided cutting [EF14] for the railway line extended to the north, truncating the castle ditch and the south-western corner of the castle mound (Figure 49). From this point the railway line proceeded on a steep sided embankment [EF10] which extended across the field to the west of the castle to the Grade II listed railway bridge which crosses the Tarset Burn (Figure 50). No traces of original railway features, track, or ballast were recorded within either the cutting or on the embankment. However, two iron rails were recorded on the south-west corner of the castle mound, lying across the railway fence line [EF11]. The remains of this fence line was recorded to the north of the railway cutting and embankment [EF11], and comprised a slightly raised bank with irregularly interspersed posts made from iron rails bolted around wooden posts (Figure 51). The fence line and bank extended from the bridge at the south-west to the southern edge of the castle ditch [EF15], proceeded north-west to the base, turning north-east to ascend the southern edge of the castle mound [EF16]. The bank then extended across the south-west corner of the mound (Figure 52), descended the western escarpment, and continued to run immediately parallel to the base of the railway embankment [EF10] to the north-west. Beyond the terraced bank [EF12] in the western field, the bank was accompanied by a ditch to the north-east (Figure 48). The fence line and bank terminated just prior to a trackway leading beneath the railway bridge over the Tarset Burn.

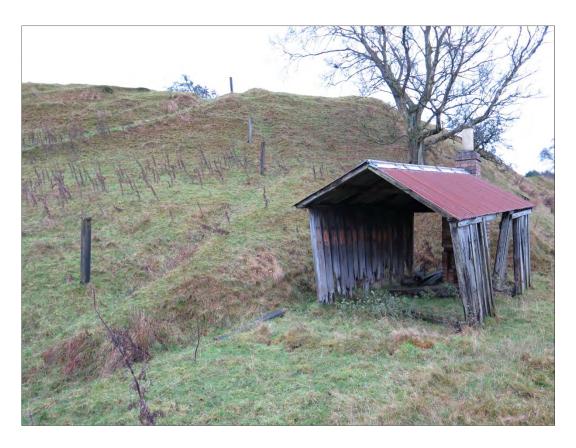
Figure 52: Railway fencing bank [EF11] running across the south-western corner of the castle mound [EF16], looking north-west

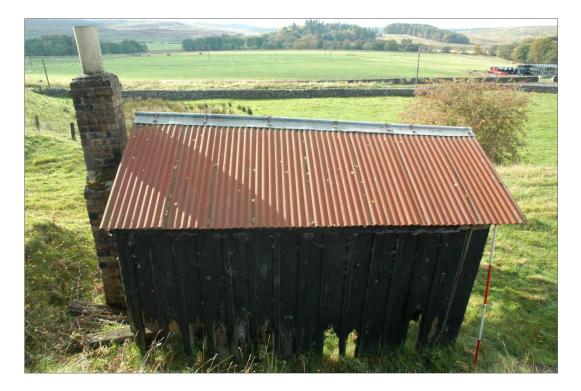
Figure 53: Lineman's hut [EF13], with railway fencing bank [EF11], looking east

- 6.14 A railway 'lineman's hut' [EF13] was recorded at the intersection of the embankment and the cutting (Figure 53). The hut is located to the north-east of the railway line, on a flat terrace partially cut into the castle mound, and measures approximately 3.4m north-east/south-west and 4.5m south-east/north-west. The Across frame of the hut is roofed with corrugated iron, whilst the existing walls (of which only the north-east and south-west elevations survive) are constructed from re-used railway sleepers set on end with the outer surface contacted with tar (Figure 54). Several fallen sleepers were recorded lying in and around the building; the majority of the sleepers had visible impressions relating to the iron 'chairs' attached to the sleepers to hold the rails, indicating that they were re-used. There was a door in the south-west elevation, of which only the attached 'barn-door' hinges survive (Figure 55). The north-west elevation of the building is completely absent, as is much of the south-east elevation, with the exception of the chimney stack (Figure 56). The chimney is constructed from machine-made brick, and is located exterior to the main structure and topped with a ceramic chimney pot. The interior fireplace has an in situ iron grate, with fire-bricks to the rear of the hearth. The hearth stone is constructed from concrete, and a shortened iron railway sleeper has been used to form the mantel (Figure 57). The building is, overall, in a dilapidated condition, with many of the standing wall sleepers in a poor and rotten condition. Additionally, the building was observed to list to the south-west, and several large cracks were present in the structure of the chimney.

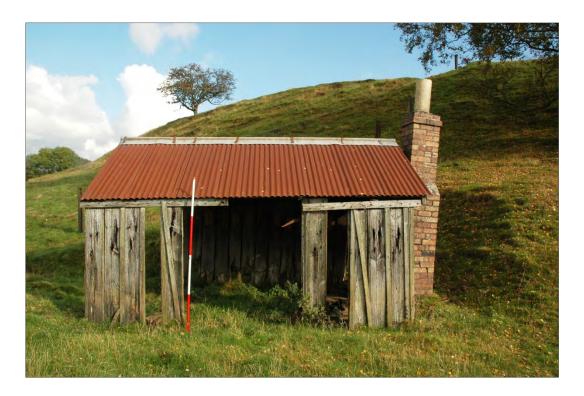
Figure 54: The north-east face of the lineman's hut, looking south-west

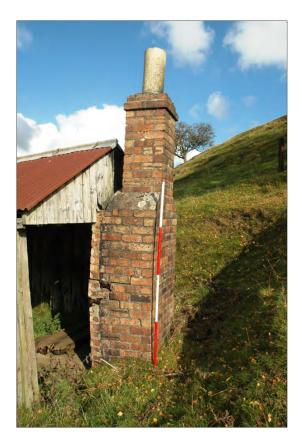
Figure 55: The south-west face of the lineman's hut, looking north-east

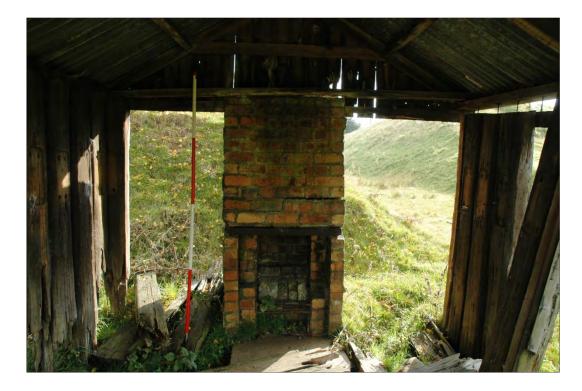
Figure 56: The brick chimney on the south-east face of the lineman's hut, looking north
