BASTLES IN TARSET

Of the 33 bastles studied by TAG

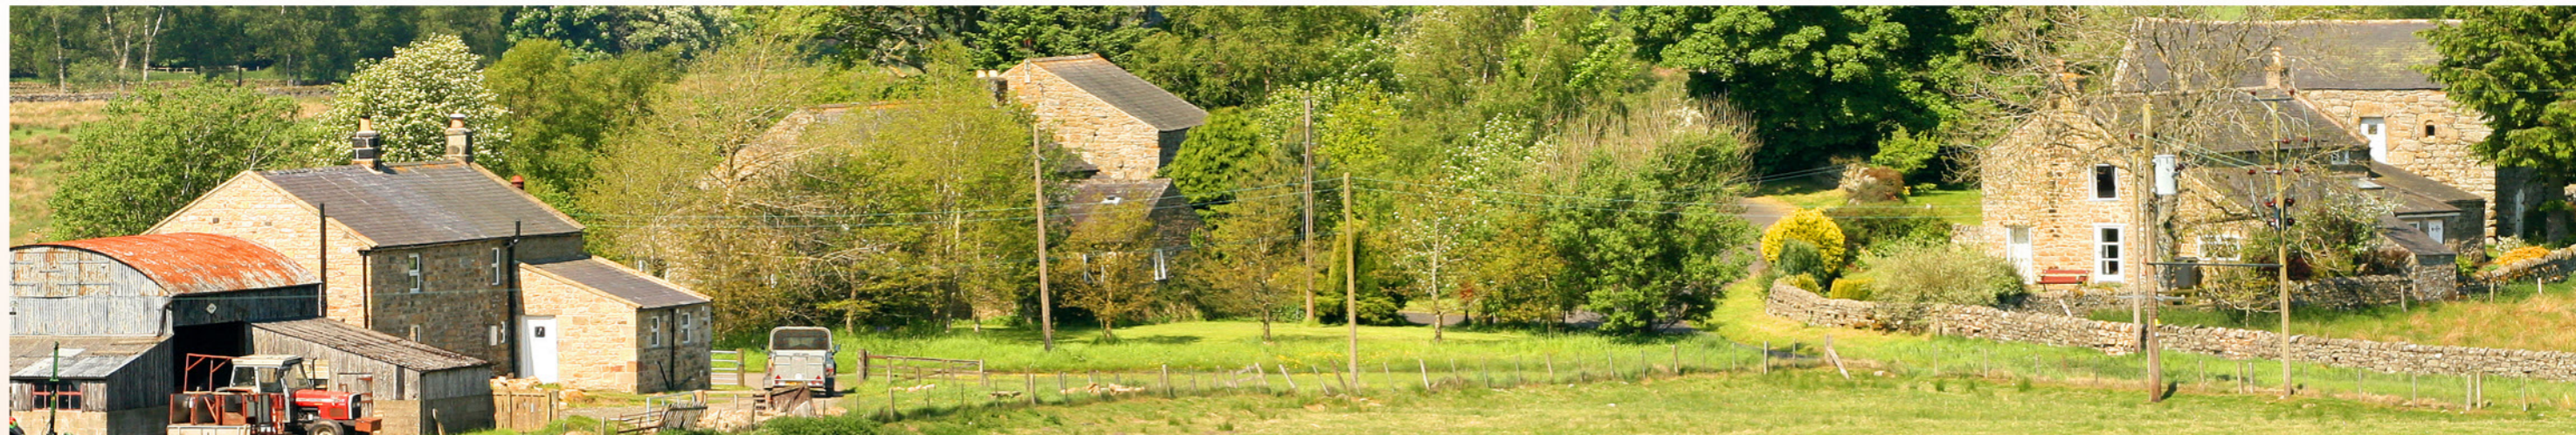
Gatehouse Bastle hamlet two bastles survive with walls intact; a third forms part of a field wall; foundations and base courses survive in the fourth; all buildings privately owned

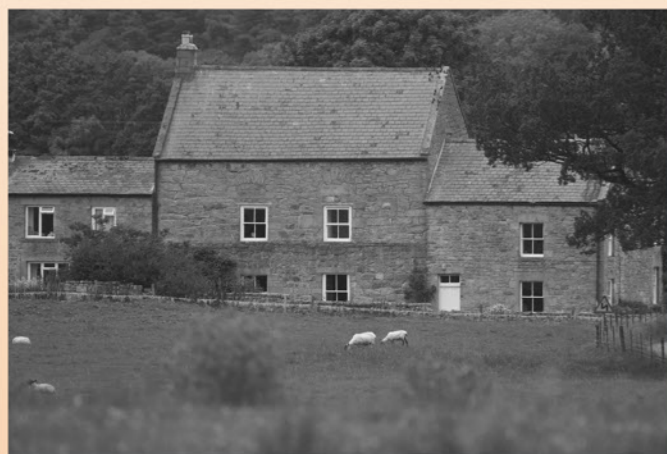
Snabdaugh an atypical bastle design with second floor vaulted stone ceiling below more modern slate roof; Grade 1 listed; now a private house

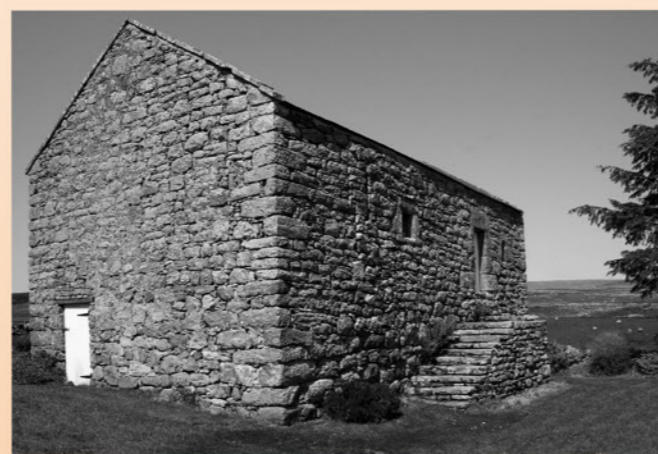
North Gatehouse intact masonry with external stairs in two sections; re-roofed in slate; later doorway on ground floor; blocked upper doorway at back led to former hay loft; Scheduled Ancient Monument, Grade 2* listed; privately owned

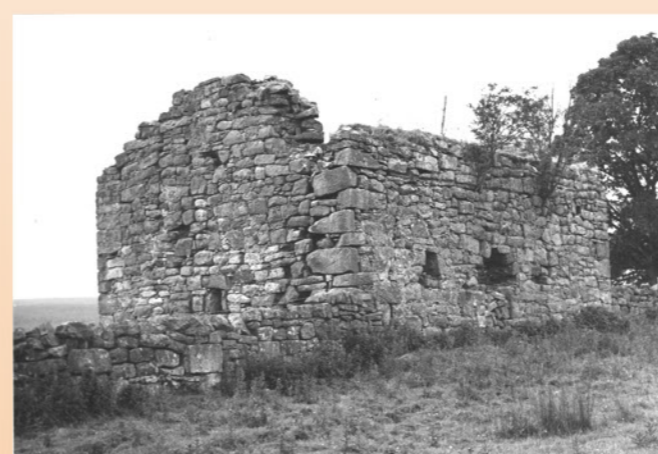
South Gatehouse building roofless by 1970; original walls in poor condition; front (south) wall rebuilt to incorporate windows and doorways; partly rebuilt by owners in 1992; Scheduled Ancient Monument, Grade 2 listed; privately owned

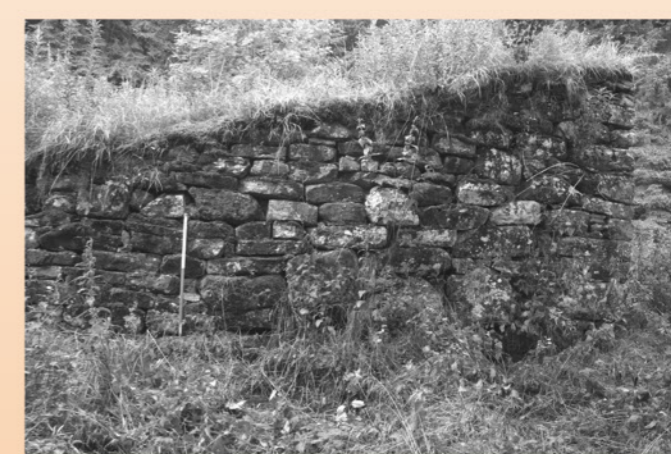
Boghead conservation work in process; parts of 4 walls survive; asymmetrical gable walls; interior rubble-filled from collapse of vault; scheduled Ancient Monument, Grade 2 listed, public access on foot only

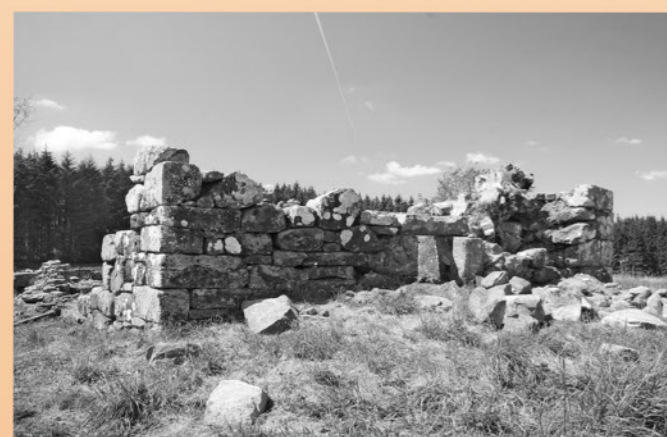
Shilla Hill sections of all 4 walls survive; 2009 consolidation work. Scheduled Ancient Monument; public access on foot only through forest

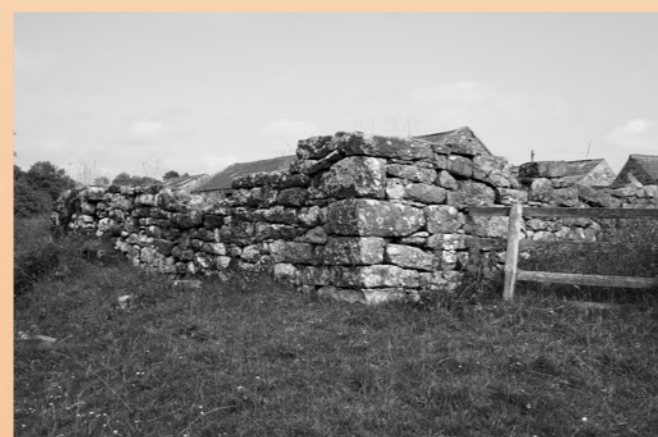
Burnmouth 1 first bastle at this site, incorporated in boundary wall; on private land, this view from public road

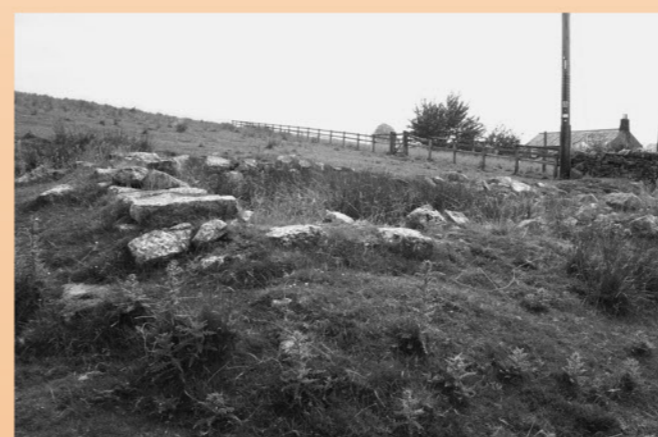
Burnmouth 2 second bastle at this site; walls have been robbed, probably for other buildings on site; on private land

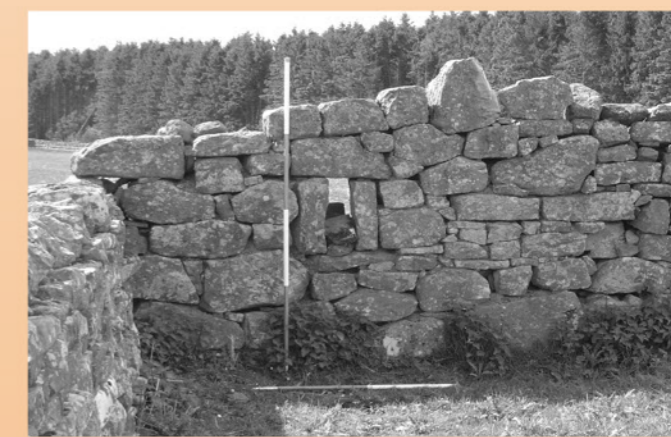
Highfield 1 one of 3 possible bastles at this site; some original foundation survives; fragments of worked stones found on site and in farm buildings; on private land
